**Technical Service  
BULLETIN**

**M.I.L. "ON" DTC P0171 AND/OR P0174:  
ENGINE RUNNING LEAN**

**'04 Camry, Sienna & Solara (3MZ-FE)**

**ENGINE  
EG029-04**

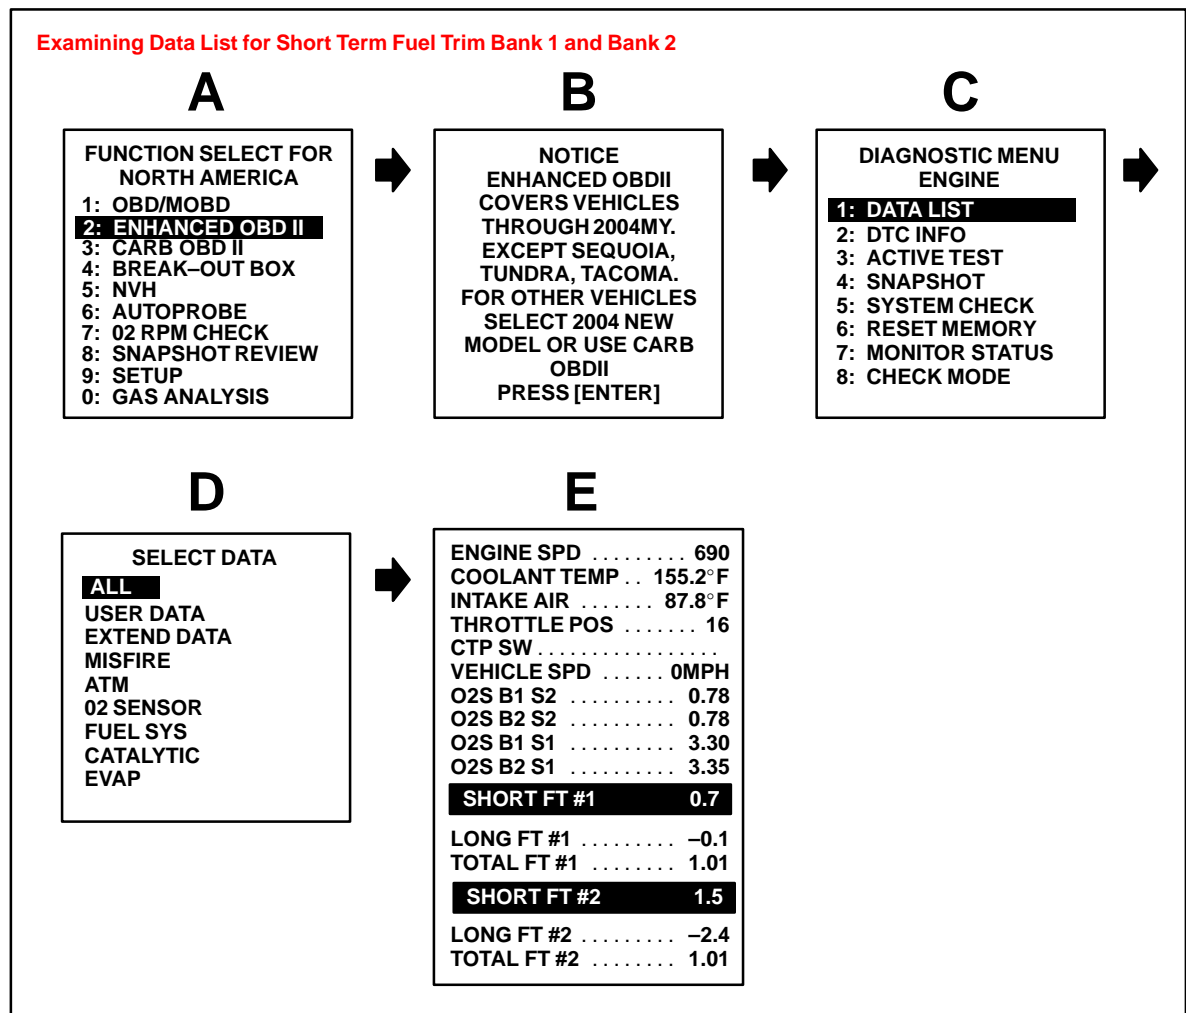
1. Monitor the Bank 1 and Bank 2 Short Term Fuel Trim in the Data List.

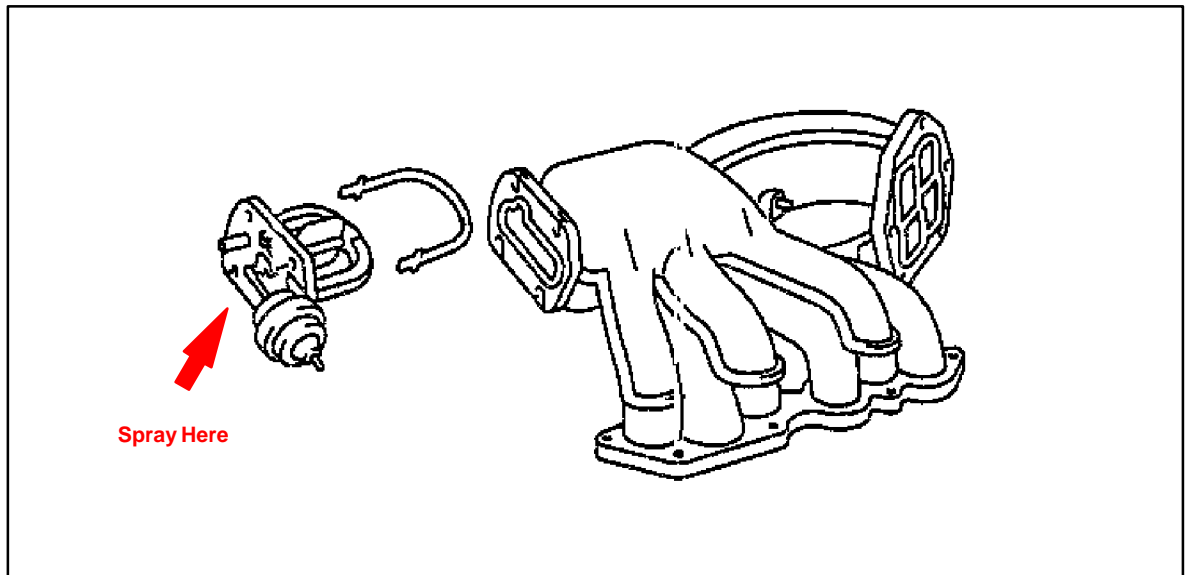
2. Spray carburetor cleaner near the Intake Air Control Valve pivot shaft and monitor Short Term Fuel Trim as indicated in step 1.

**If Yes** – Replace the Intake Air Control Valve. Refer to the Technical Information System (TIS), 2004 model year applicable model Repair Manual: *Intake: Intake Air Control Valve Assy No. 2 (3MZ-FE): Replacement*.
