Technical Service BULLETIN

STEERING INTERMEDIATE SHAFT NOISE

'04 Sienna

ST003-04

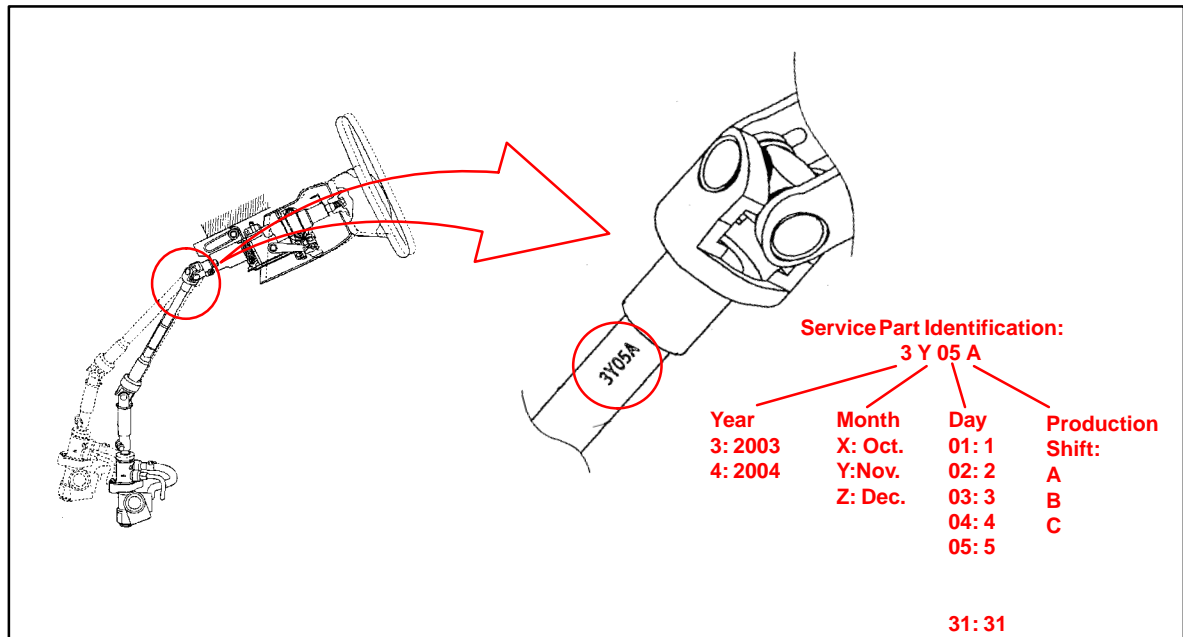
Countermeasure service parts are identified by the 5-digit date code located on the upper portion of intermediate shaft, just above the rubber grommet. Date code is 3Y05A, or last 2 numbers greater than 05.
