**Technical Service
BULLETIN**

DOOR CHECK POPPING NOISE

'04 – '06 Sienna

REVISED
NV003-07
NVH

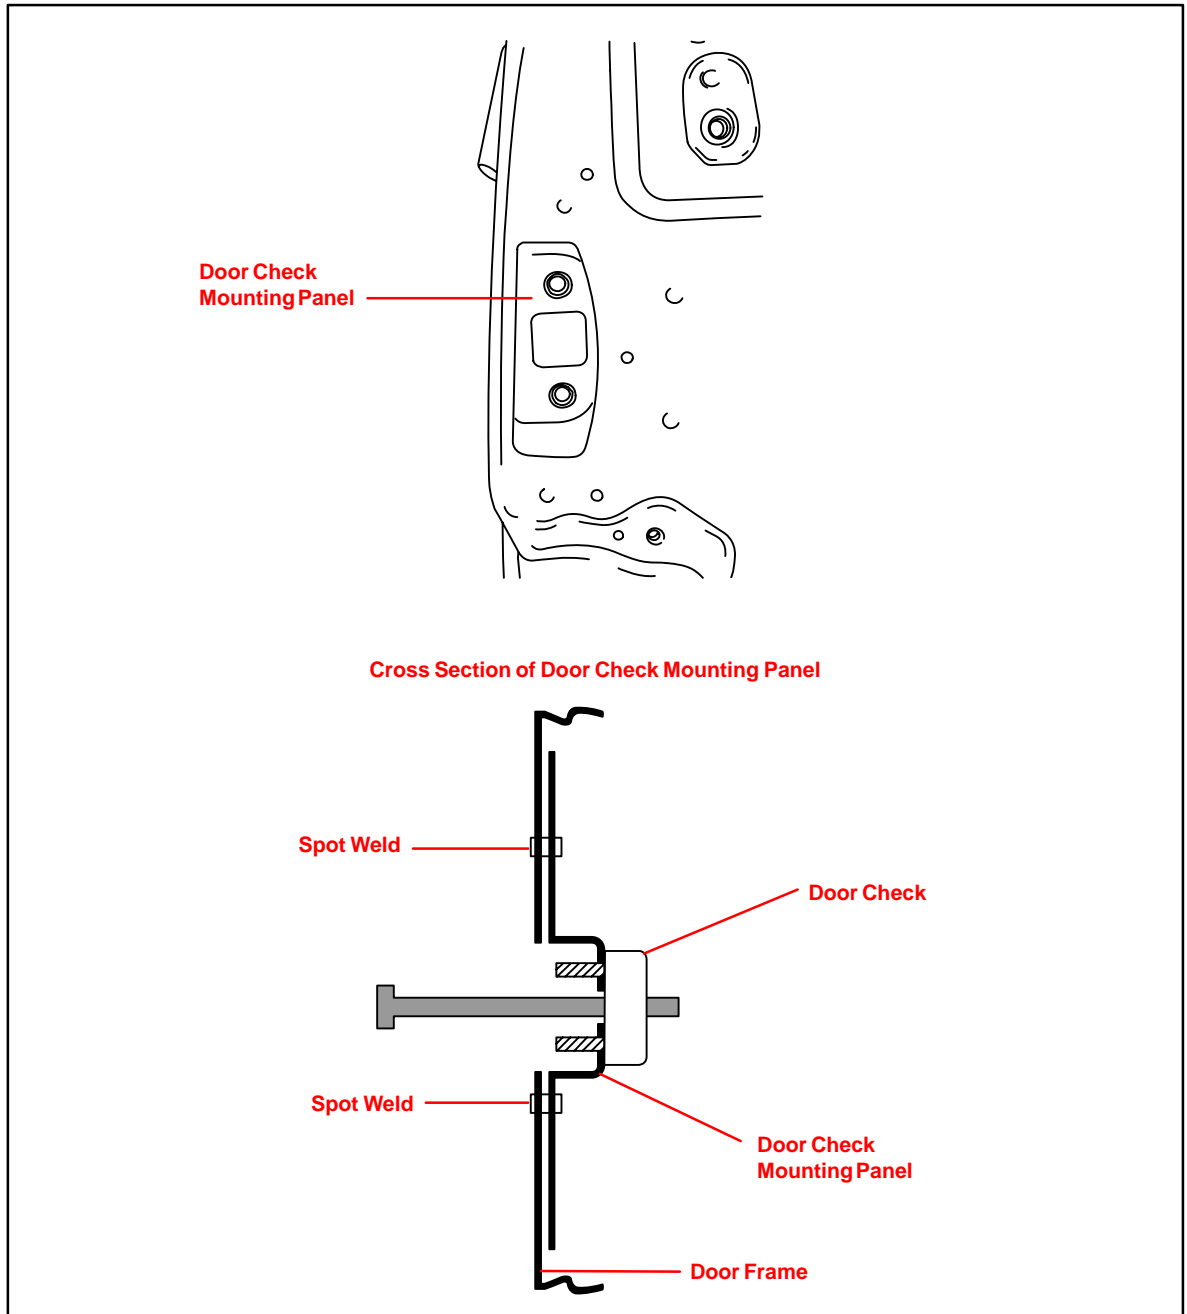
1. Confirm that a spot weld has separated by pushing on the door check mounting panel. If the panel can be pushed in by hand, the weld is loose.

2. At the spot weld, drill an 8.0-mm (0.32-in.) hole through the door frame ONLY.

3. Fill the drilled area using a MIG welder to connect all panels.
4. Use an appropriate color touch up paint on the welded material.
