Technical Service BULLETIN

STEERING INTERMEDIATE SHAFT NOISE

'04 Sienna

ST003-04

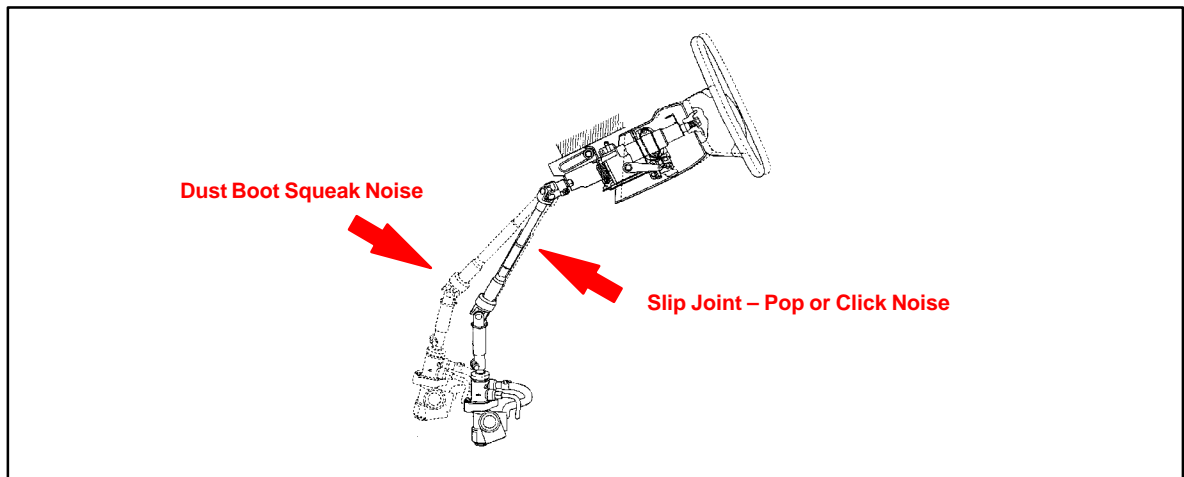
Introduction In some 2004 model year Sienna vehicles, a squeak, pop or click noise is heard or felt in the steering wheel while making turns. This bulletin provides repair procedures that have been developed to address these concerns.

Countermeasure service parts are identified by the 5-digit date code located on the upper portion of intermediate shaft, just above the rubber grommet. Date code is 3Y05A, or last 2 numbers greater than 05.
